The Chesapeake Bay Breakwater Database Project Hurricane Isabel Impacts to Four Breakwater Systems

Shoreline Studies Program
Virginia Institute of Marine Science
College of William & Mary

May 2005

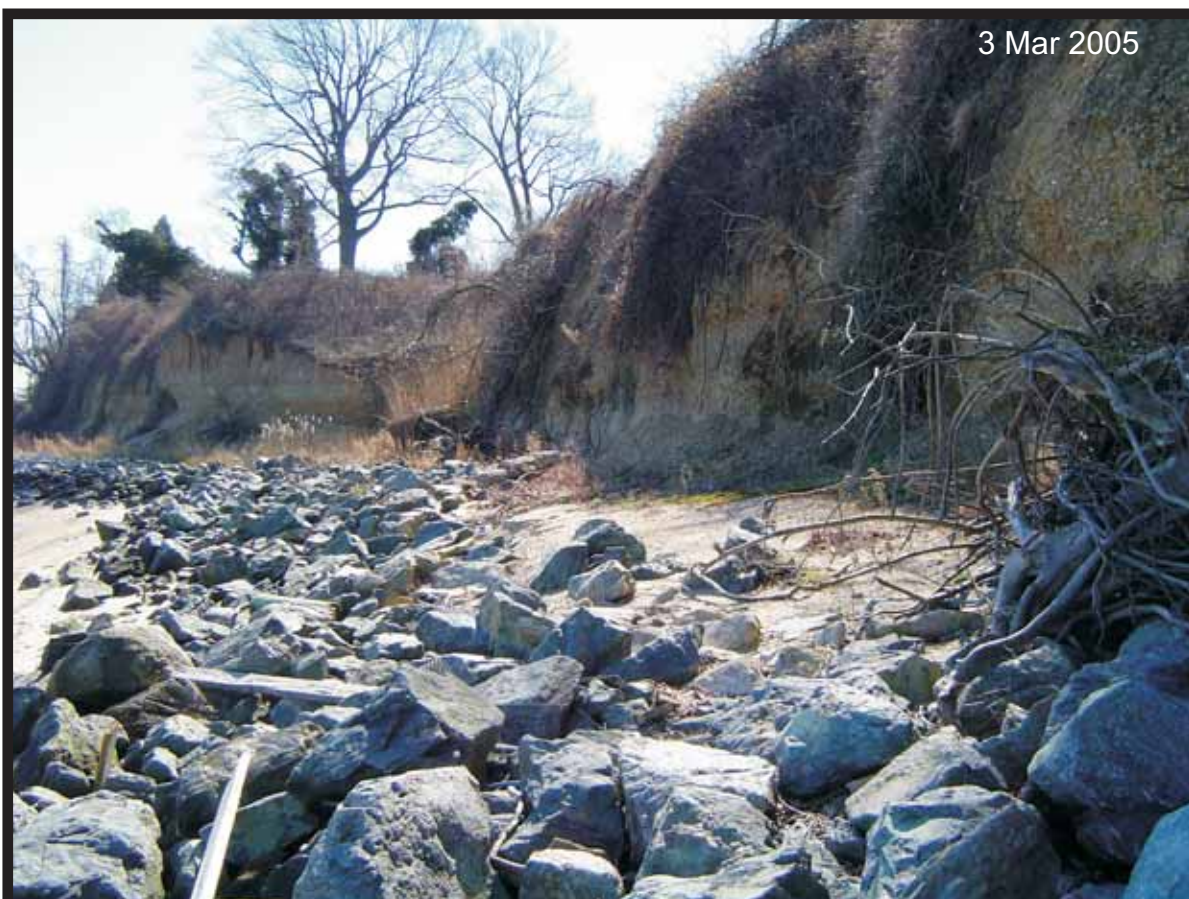
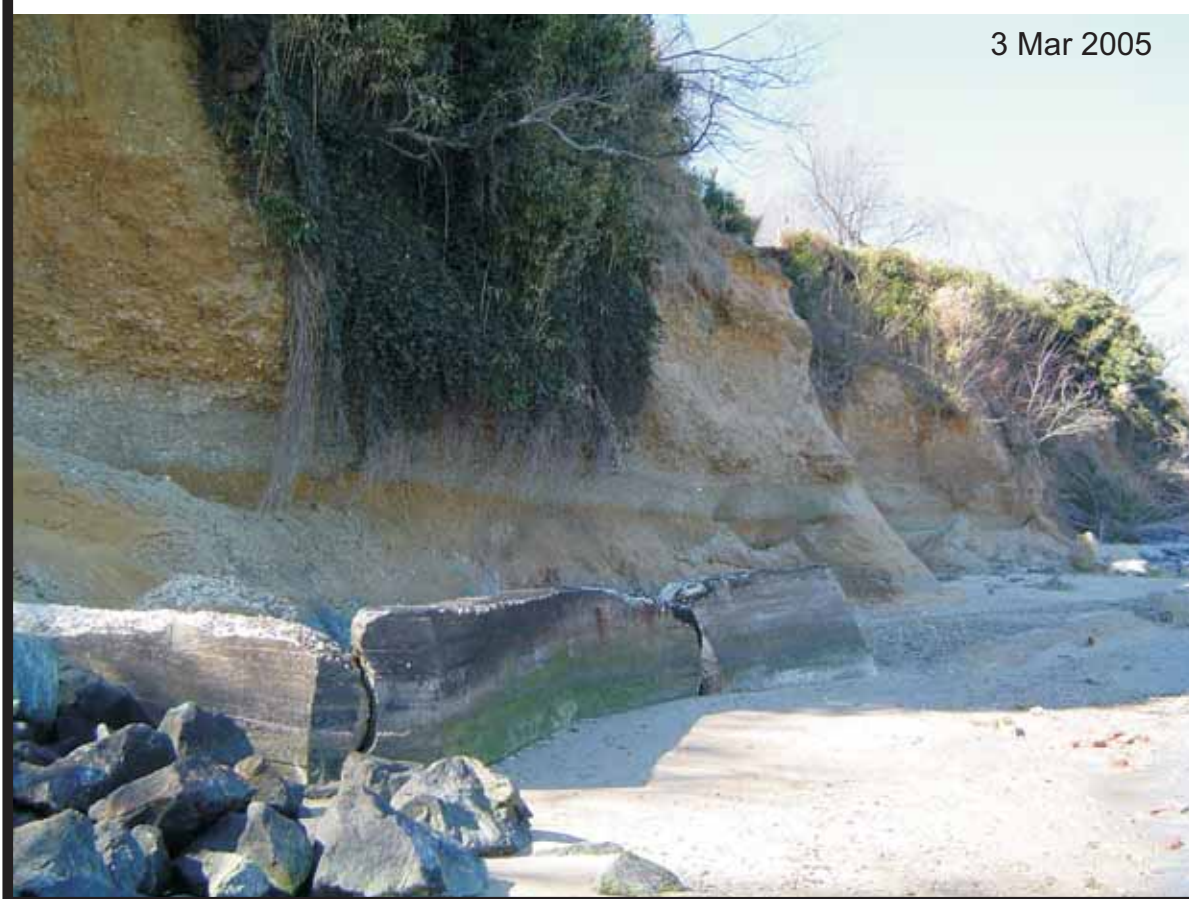
Figure 37. Impacts to the shoreline downriver from Yorktown Beach at the National Park Service's Moorehouse.
